## HOME INSPECTIONS

## Home Inspection Report

**444 Sample**

Inspected on Wed, Sep 18 2019 at 10:00 AM

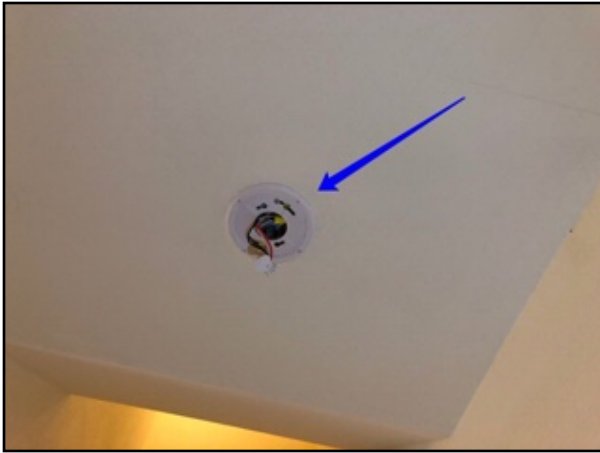
Figure 5-1

Smoke detector downstairs and in one of the upstairs bedrooms are missing. Recommend replacing smoke detectors to help promote safety in the home.

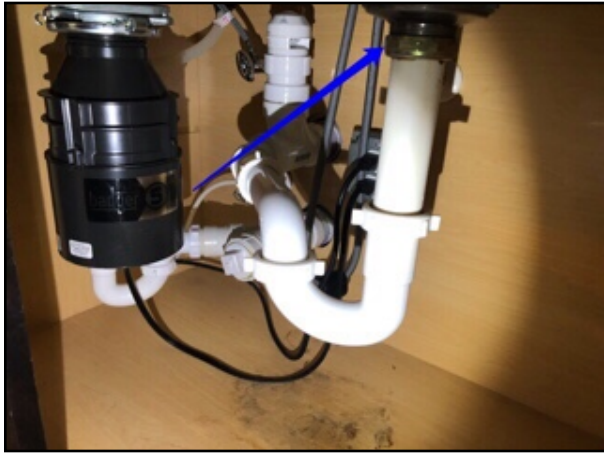
Figure 12-1

Active plumbing leak under the kitchen sink.

The connection from the sink to the drainage pipe was leaking during the time of inspection.

Recommend correction and further evaluation by a licensed plumbing contractor.

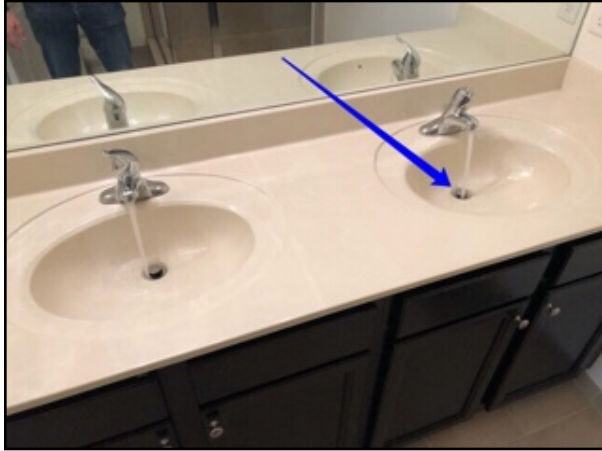
Figure 13-1

Master bathroom sink was leaking during the time of inspection. The pipe that connects to the drainage line was leaking when I touched it. Recommend correction and further evaluation by a licensed plumbing contractor.

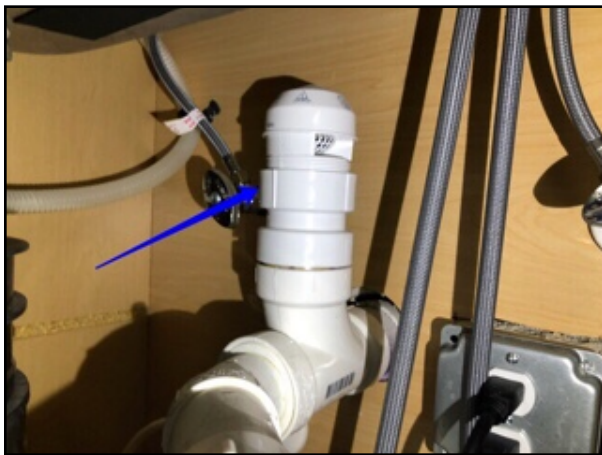
Figure 14-1

This is an automatic air vent underneath the kitchen sink,  
These are not conventional venting installations for the plumbing system  
And are common source of problems. Recommend monitoring and up-keeping to  
help maintain proper draining function around the kitchen sink.

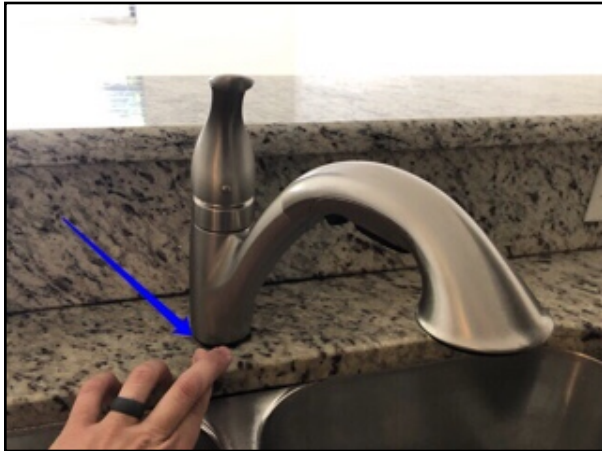
Figure 15-1

**Comment 15:**  
Kitchen sink faucet was very loose during the time of inspection.  
Recommend correction and further evaluation by a licensed contractor.

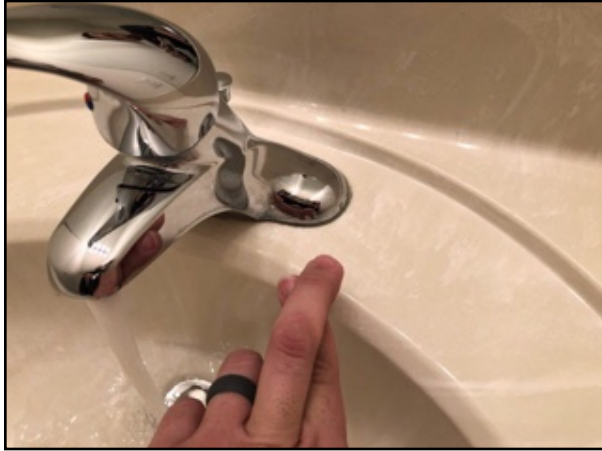
Figure 16-1

**Comment 16:**  
Sink faucet in downstairs bathroom is loose and improperly installed.  
Recommend correction by a licensed plumbing contractor.

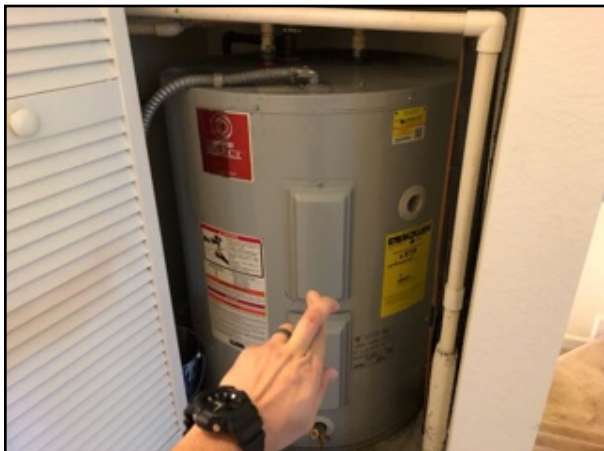
Figure 17-1

Water heater was not functioning at the time of inspection.  
Water heater Was also showing signs of rusting at its base.  
Recommend correction by a licensed plumbing contractor.

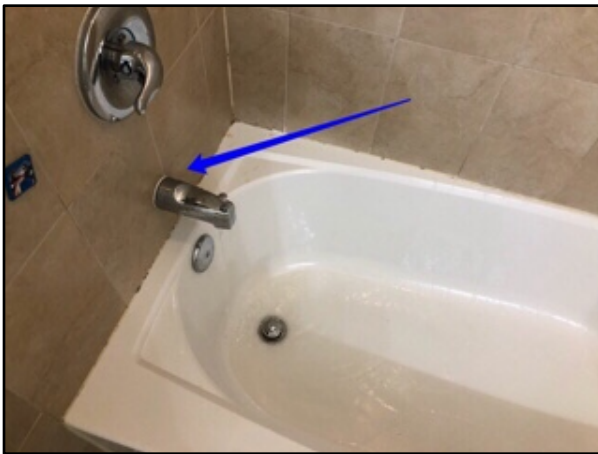
Figure 19-1

Comment 19:  
Recommend replacing caulking around the lower shower faucet.  
Do this to help prevent water intrusion into the wall structure.

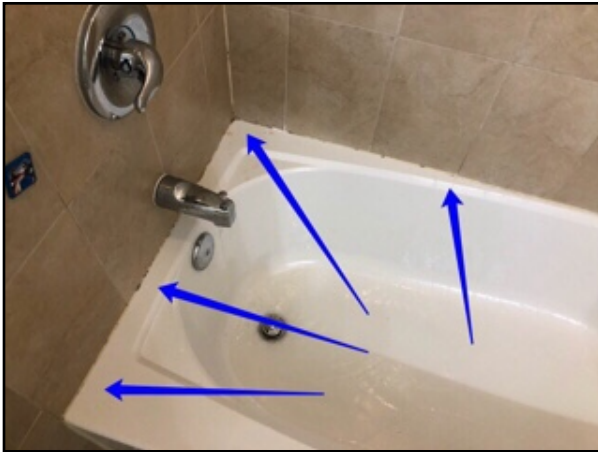
Figure 20-1

**Comment 20:**  
Recommend replacing worn caulking around the tub to help prevent moisture intrusion into wall structure.

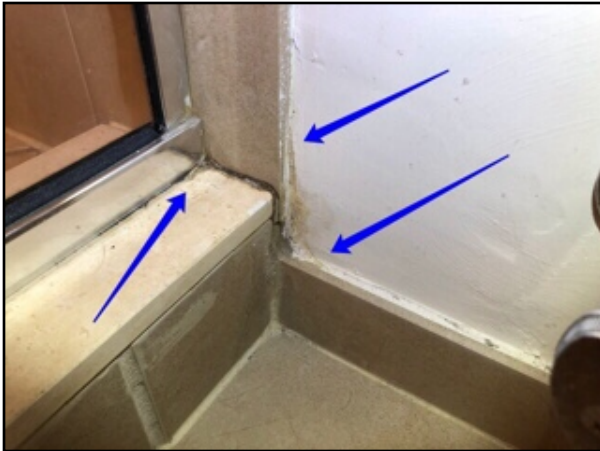
Figure 21-1

Water from the shower is making its way through the shower panel tracks and affecting the wall closest to the toilet.

Recommend replacing the caulking in this area to help prevent any more moisture damage.

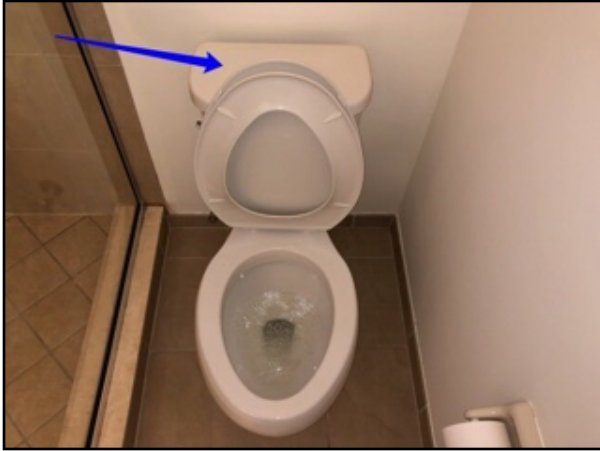
Figure 23-1

Toilet mechanism was stuck when I first started inspecting this area after I moved it manually it began working properly again. After several attempts the mechanism was still working fine.

Recommend monitoring to see if it gets stuck again. If it does I recommend repair by replacing the tank flushing mechanism.

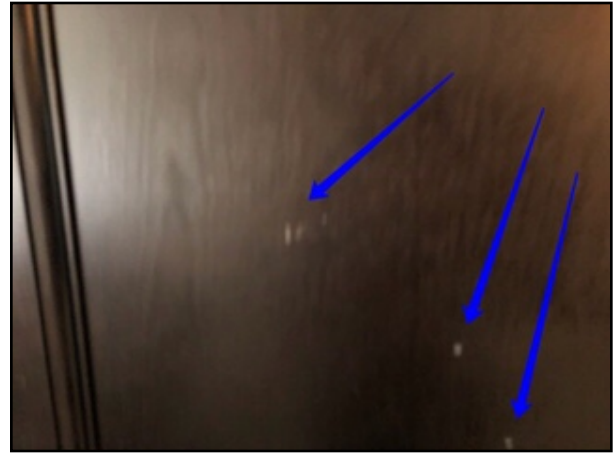
Figure 24-2

Comment 24:  
Minor chips and scratches on kitchen cabinets.

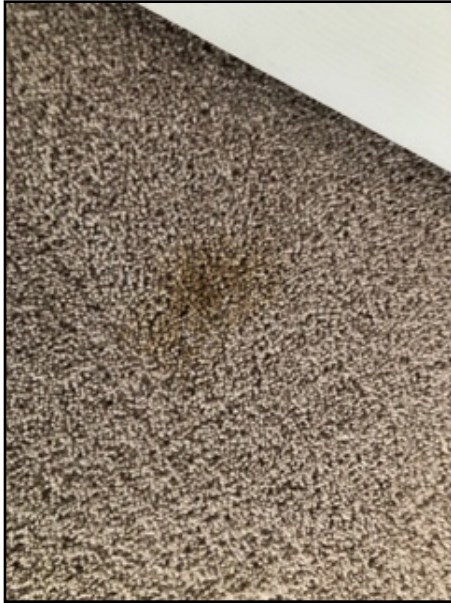
Figure 35-1

Comment 35:  
Carpet stains in upstairs bedroom.

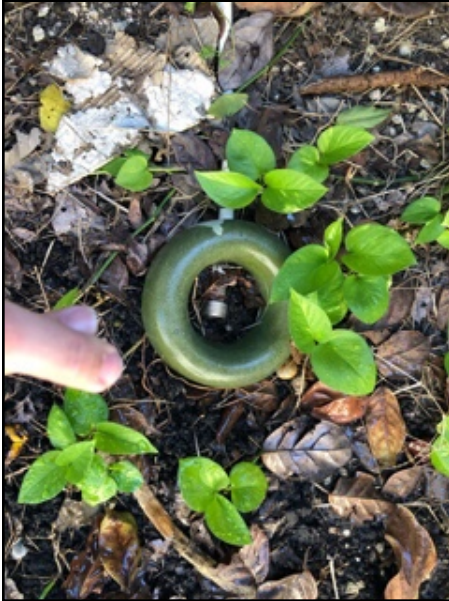
Figure 36-1

One of the sprinkler heads in the back of the house is missing and area is not being sprinkled correctly. Recommend installing new sprinkler head to return system to intended performance.

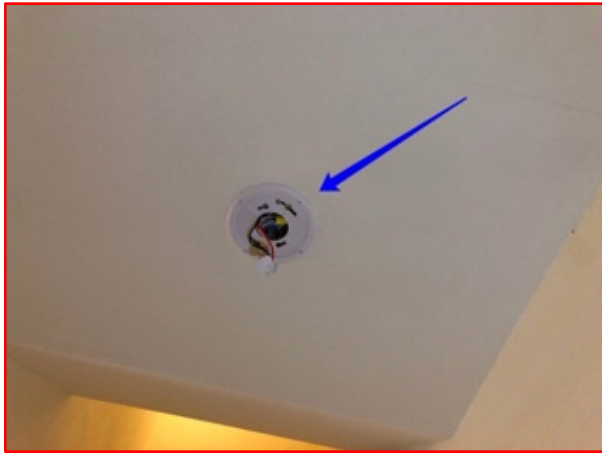
Figure 5-1

1) Smoke detector downstairs and in one of the upstairs bedrooms are missing. Recommend replacing smoke detectors to help promote safety in the home.

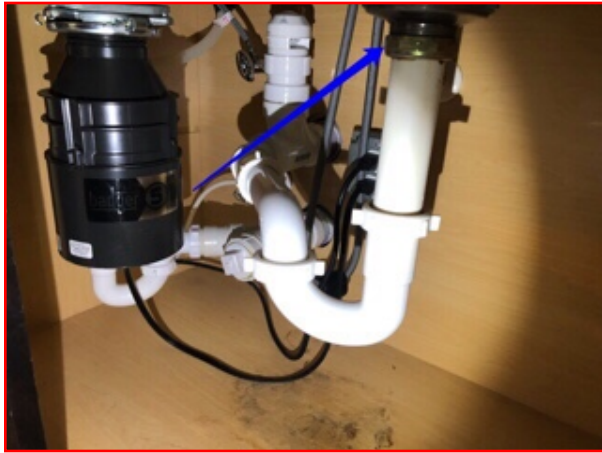
Figure 12-1

2) Active plumbing leak under the kitchen sink.

The connection from the sink to the drainage pipe was leaking during the time of inspection.

Recommend correction and further evaluation by a licensed plumbing contractor.

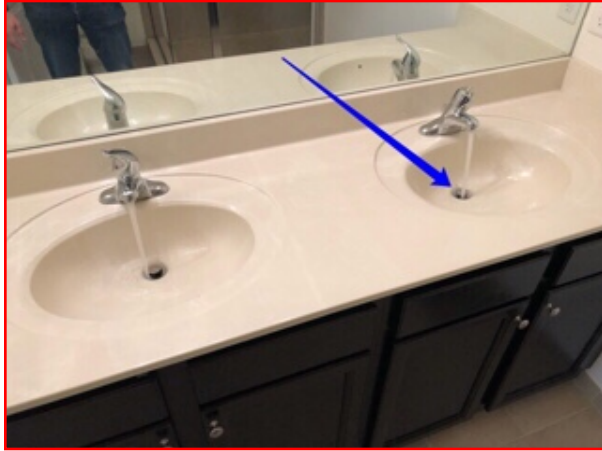
Figure 13-1

3) Master bathroom sink was leaking during the time of inspection. The pipe that connects to the drainage line was leaking when I touched it. Recommend correction and further evaluation by a licensed plumbing contractor.

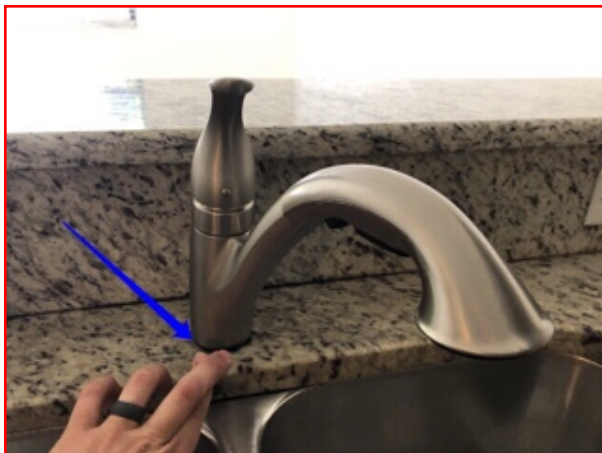
Figure 15-1

4) Kitchen sink faucet was very loose during the time of inspection.  
Recommend correction and further evaluation by a licensed contractor.

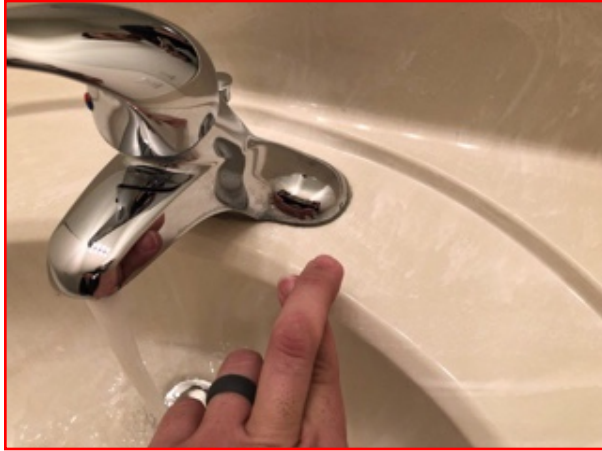
Figure 16-1

5) Sink faucet in downstairs bathroom is loose and improperly installed.  
Recommend correction by a licensed plumbing contractor.

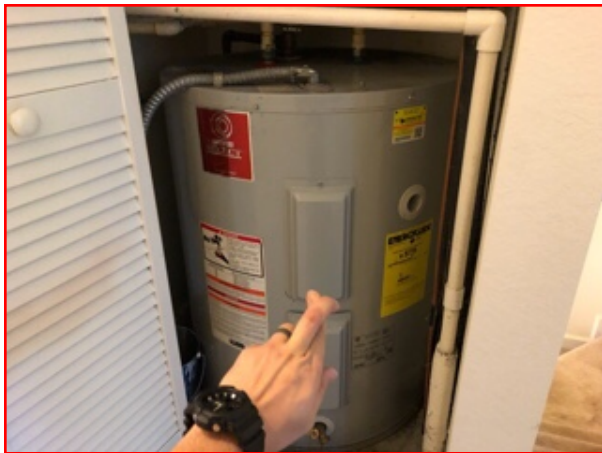
Figure 17-1

6) Water heater was not functioning at the time of inspection.  
Water heater Was also showing signs of rusting at its base.  
Recommend correction by a licensed plumbing contractor.

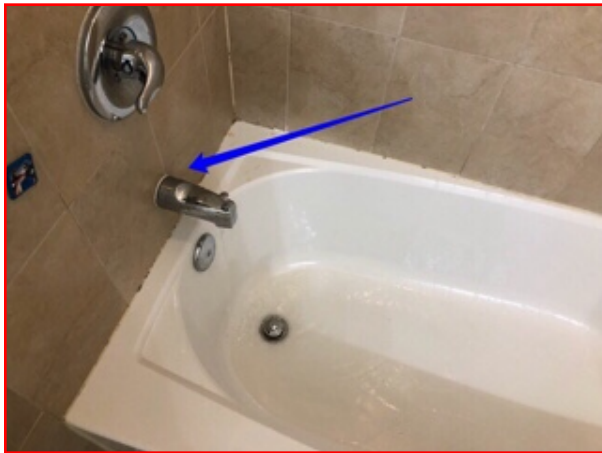
Figure 19-1

8) Recommend replacing caulking around the lower shower faucet.  
Do this to help prevent water intrusion into the wall structure.

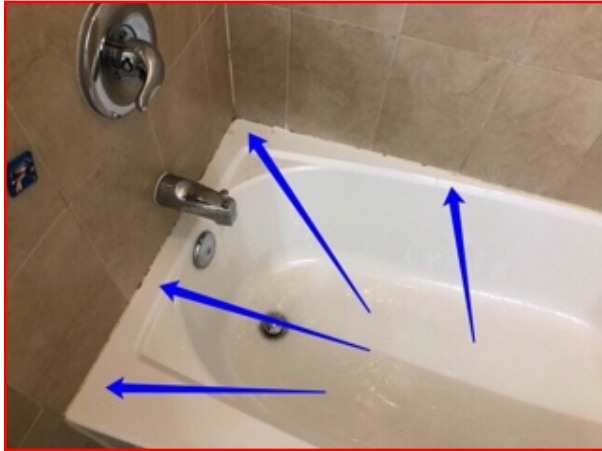
Figure 20-1

9) Recommend replacing worn caulking around the tub to help prevent moisture intrusion into wall structure.

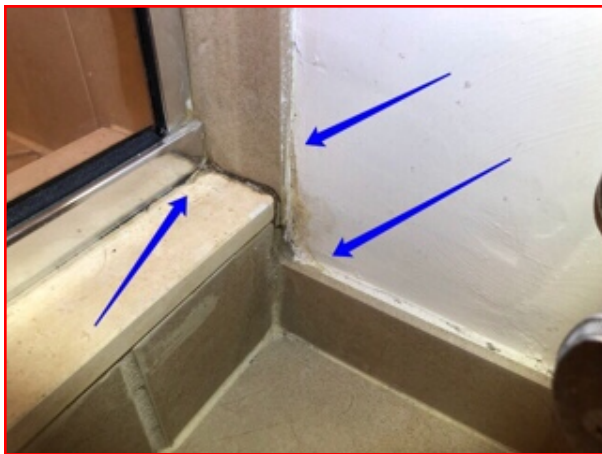
Figure 21-1

10) Water from the shower is making its way through the shower panel tracks and affecting the wall closest to the toilet.

Recommend replacing the caulking in this area to help prevent any more moisture damage.

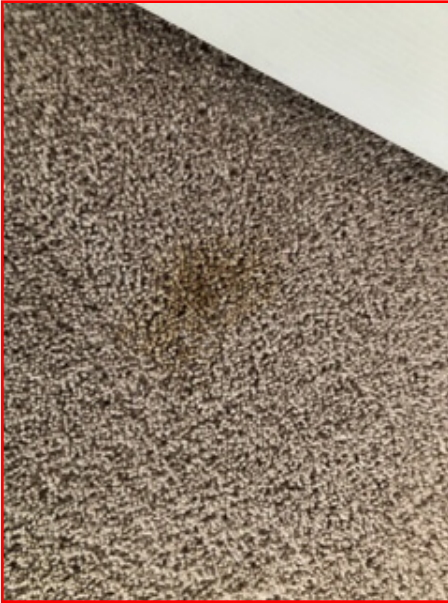
Figure 35-1

14) Carpet stains in upstairs bedroom.

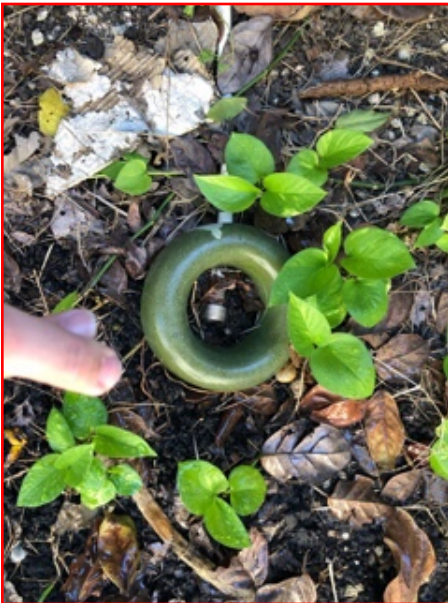
Figure 36-1

15) One of the sprinkler heads in the back of the house is missing and area is not being sprinkled correctly. Recommend installing new sprinkler head to return system to intended performance.
