## HOME INSPECTIONS

## Home Inspection Report

**444 Sample**

Inspected on Wed, Sep 18 2019 at 10:00 AM

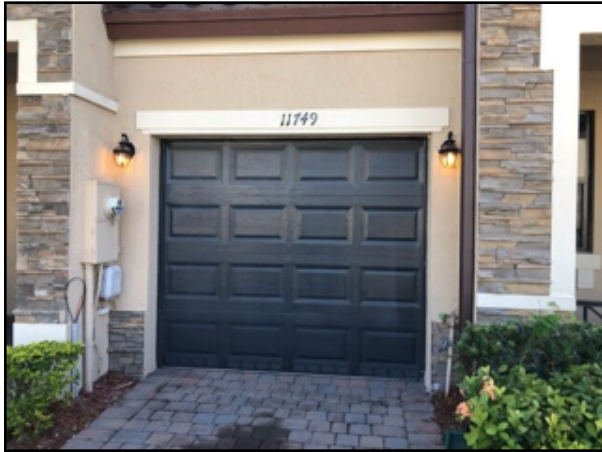
Figure 1-1

Comment 1:  
Garage door .

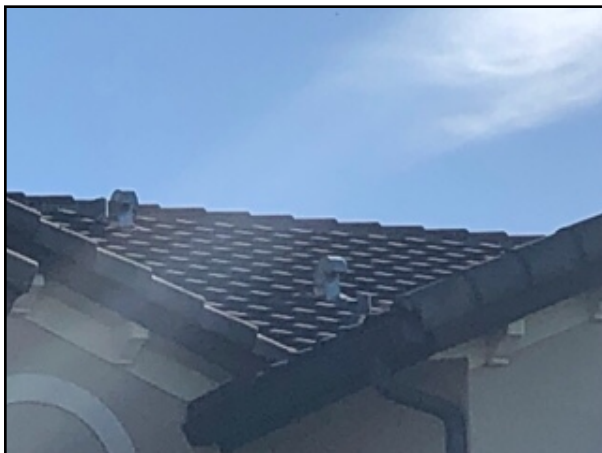
Figure 3-1

There were no signs of damage from my vantage point.

There were no signs of any roof leaks or water intrusion into the attic at the time of inspection.

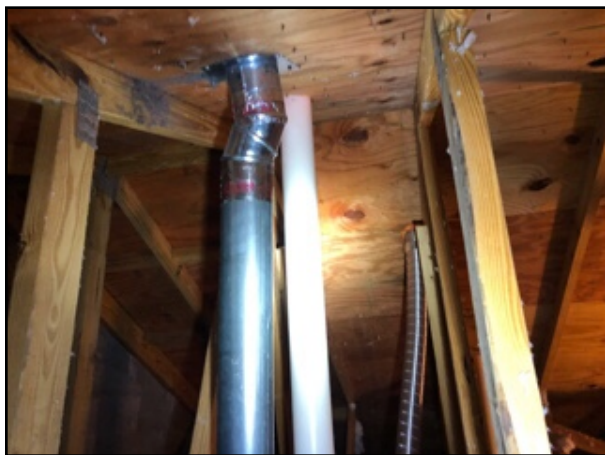
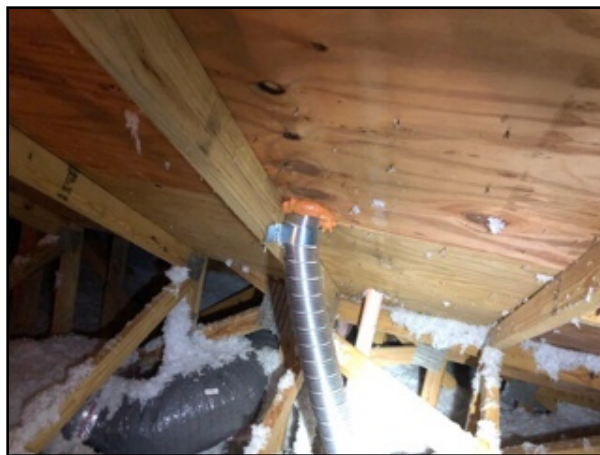
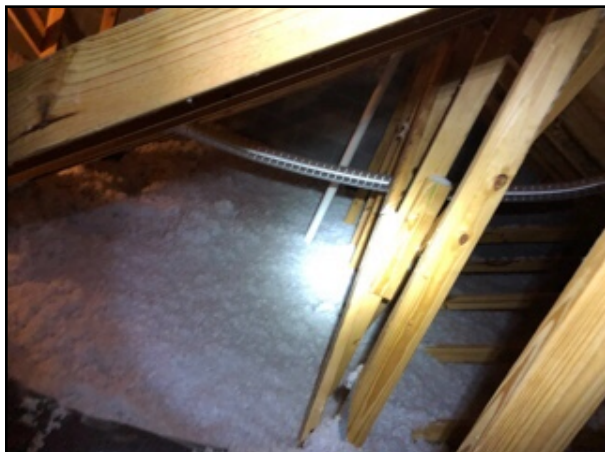
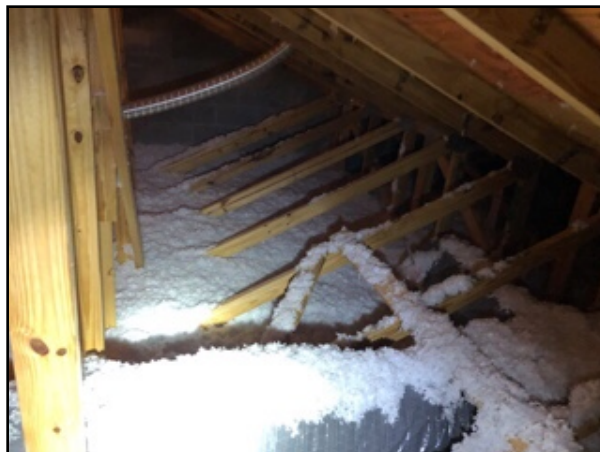
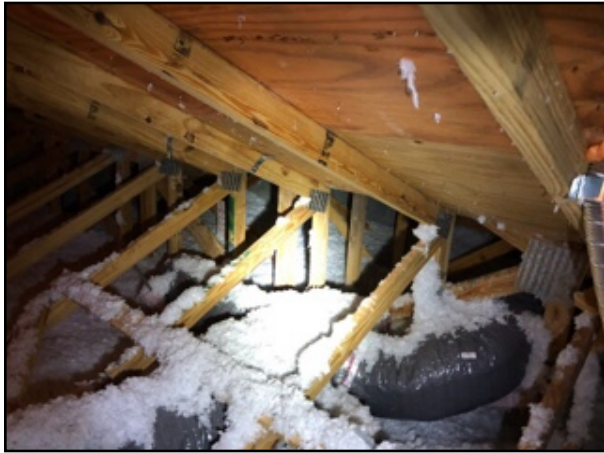
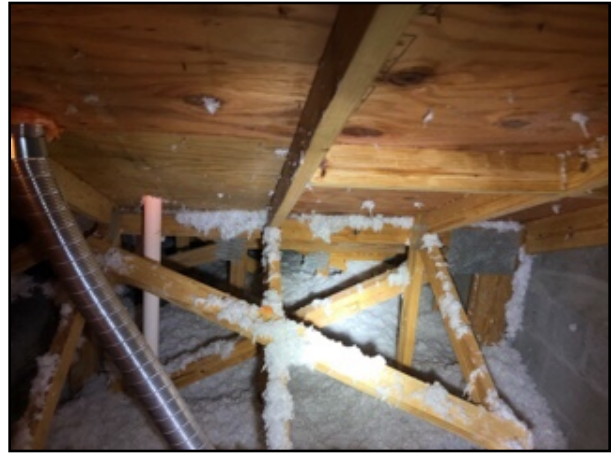
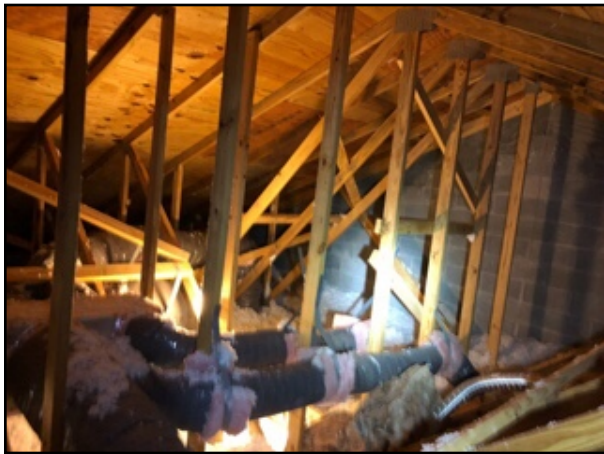
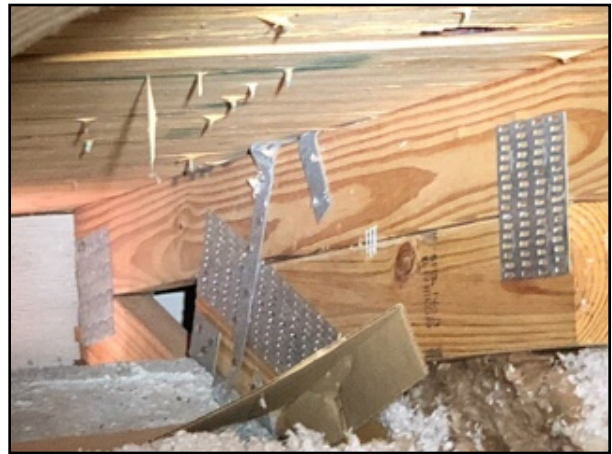
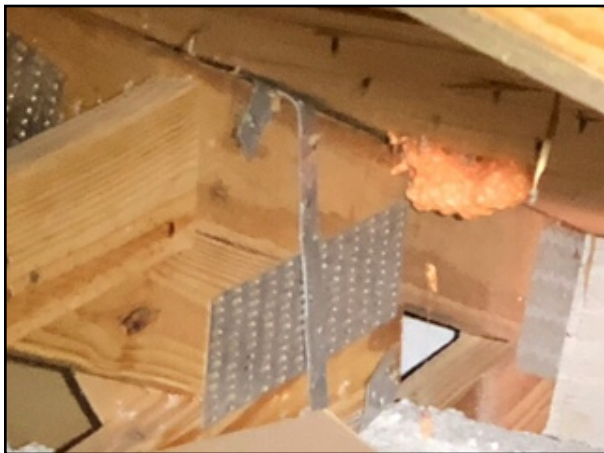
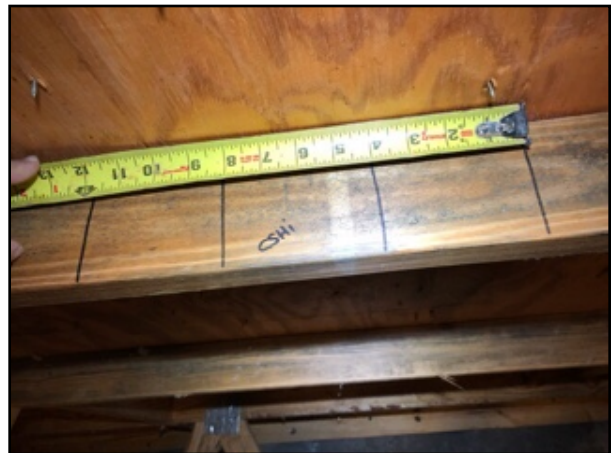
Comment 4:  
Attic .

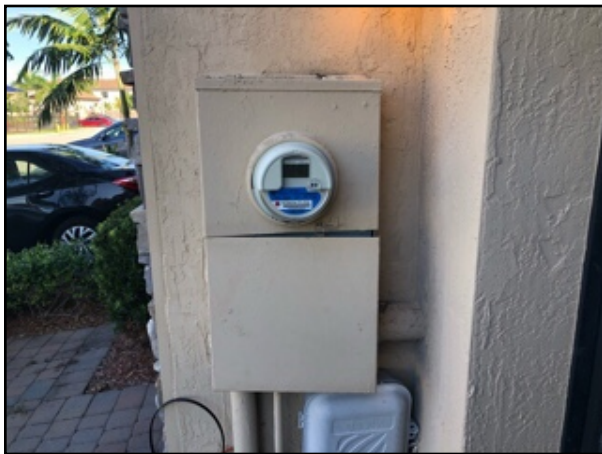
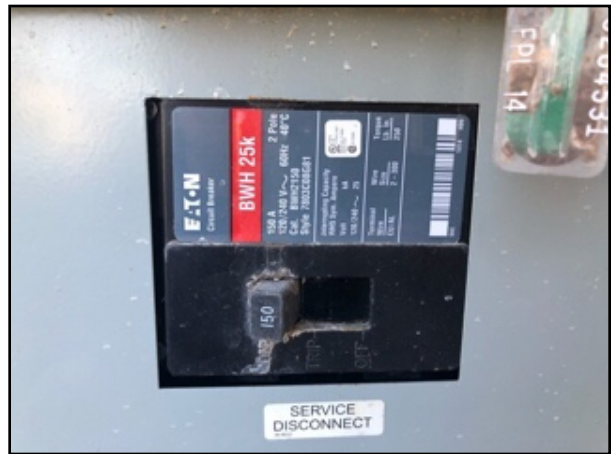
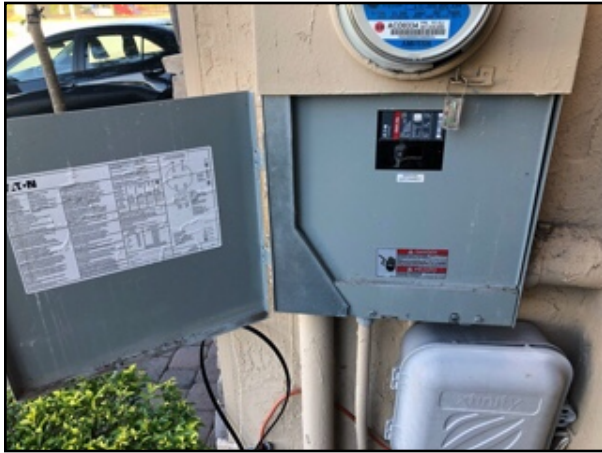
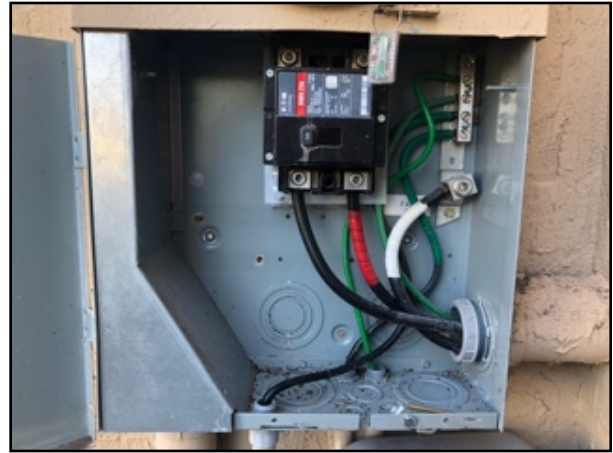
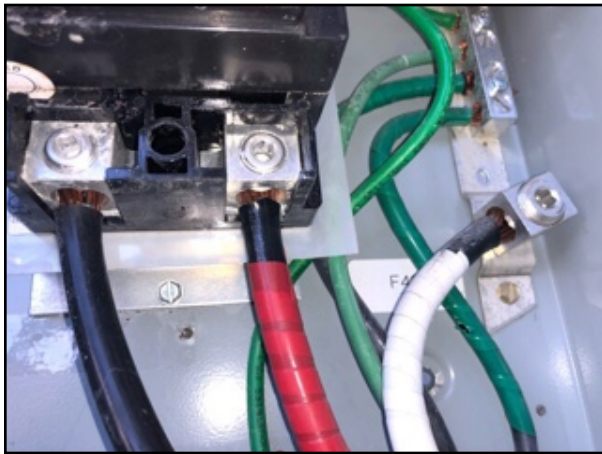
Comment 6:  
Electrical meter/main .

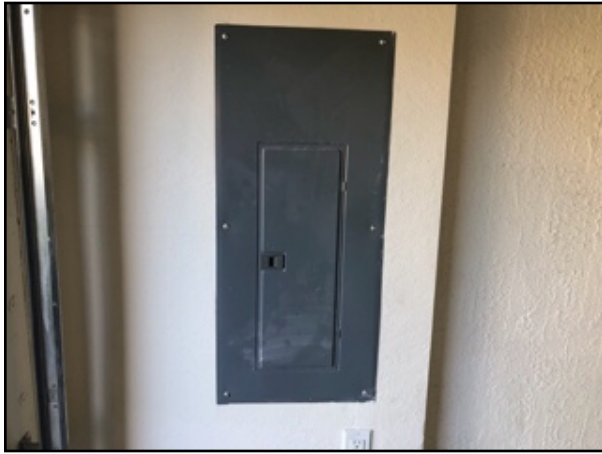
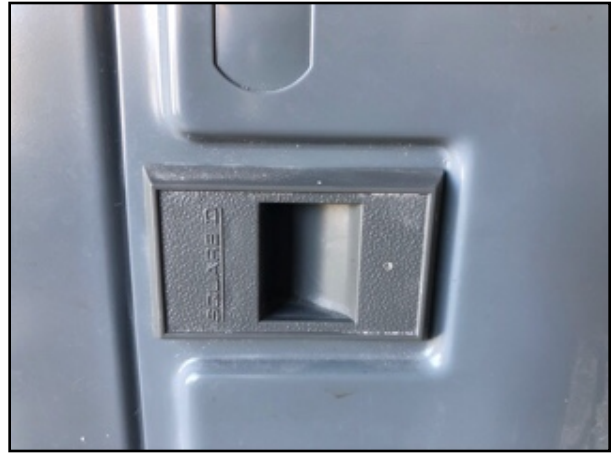
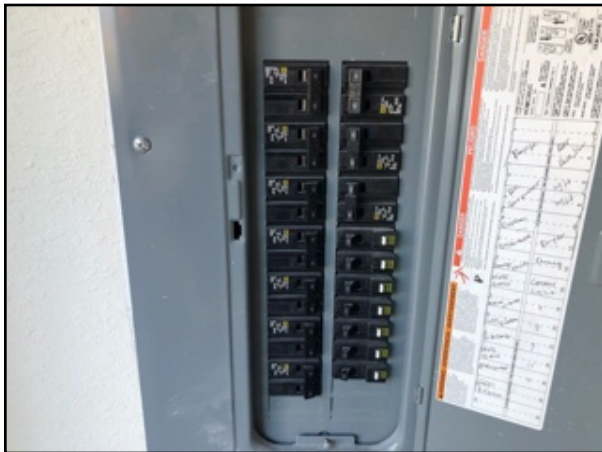
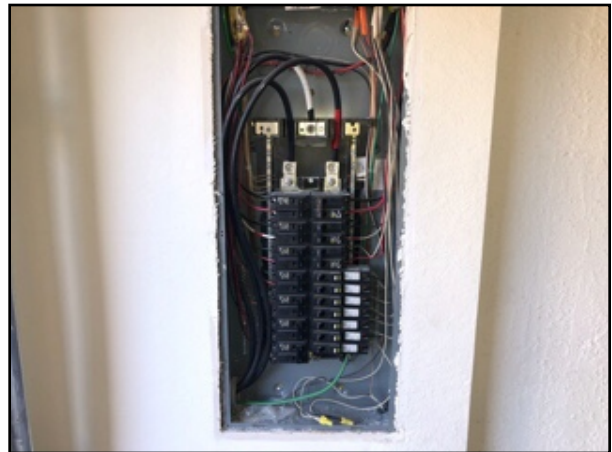
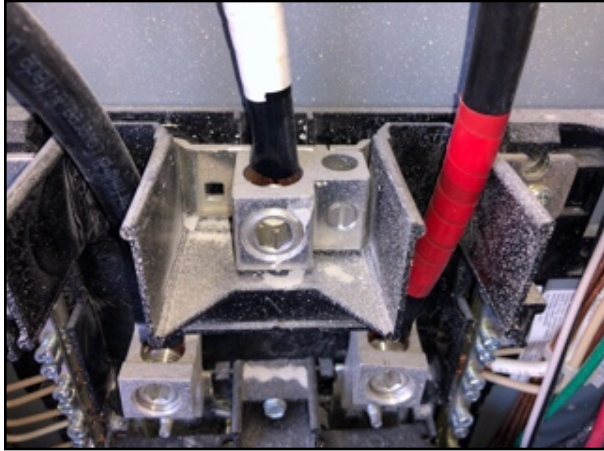
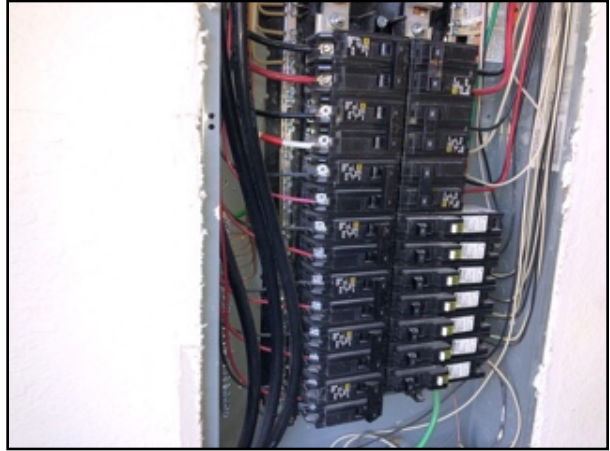
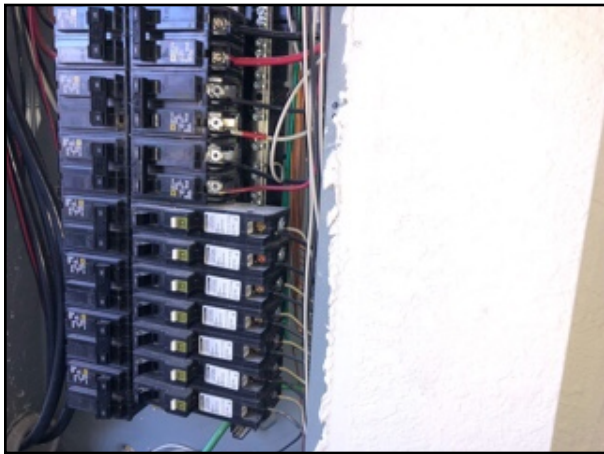
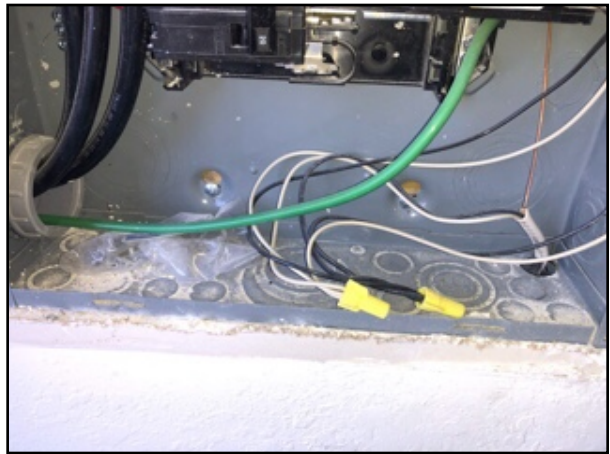
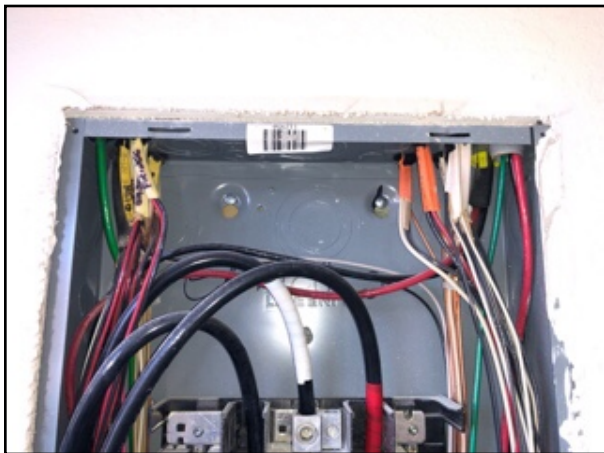
Comment 7:  
Interior/garage electrical panel .

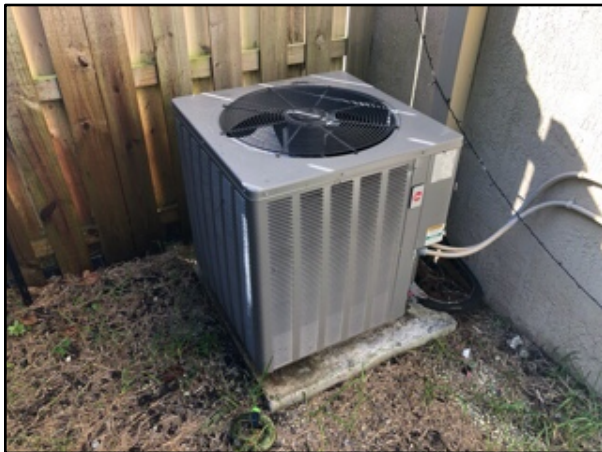
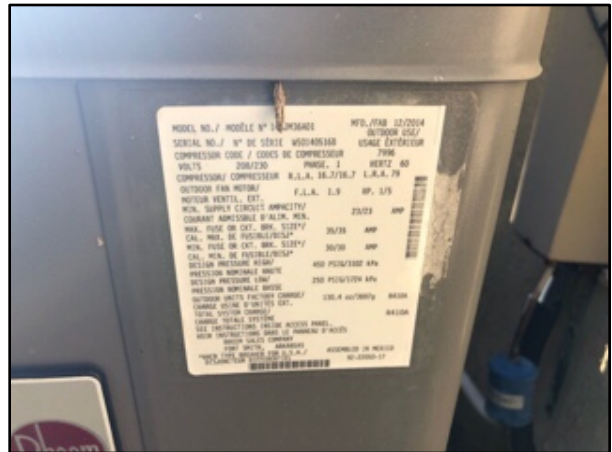
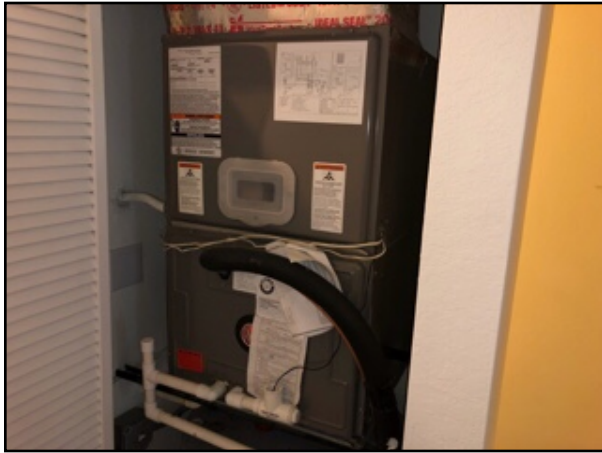
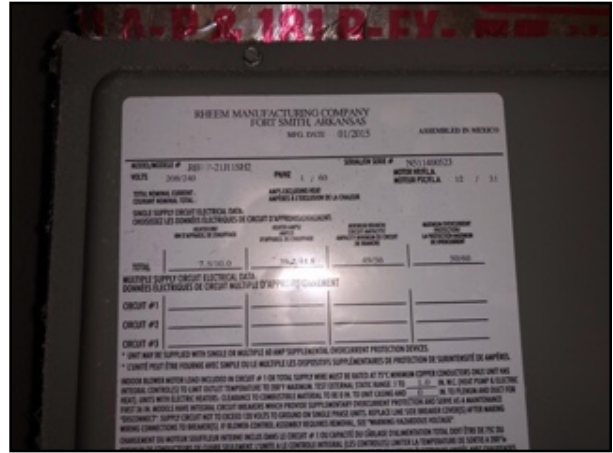
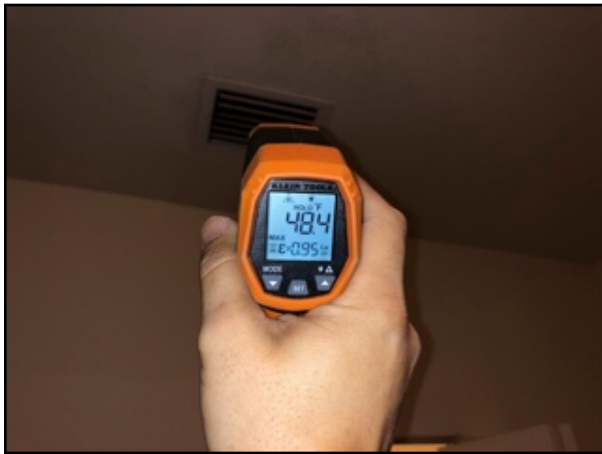
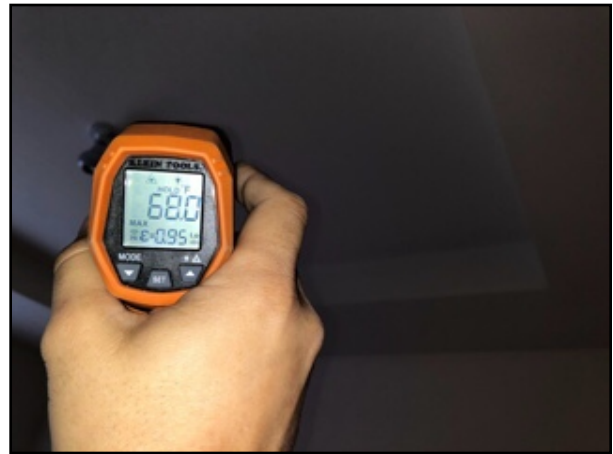
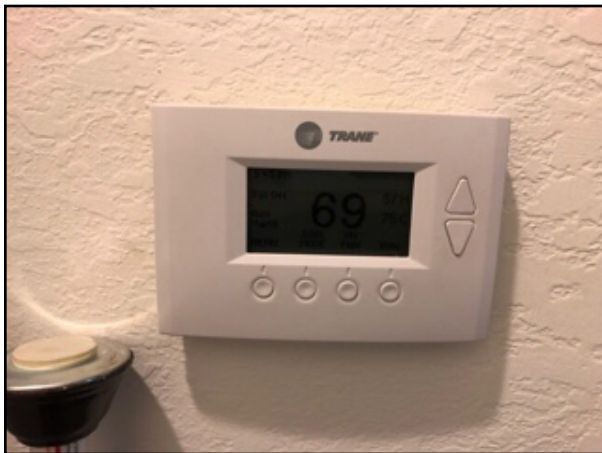
## Comment 8: HVAC system .

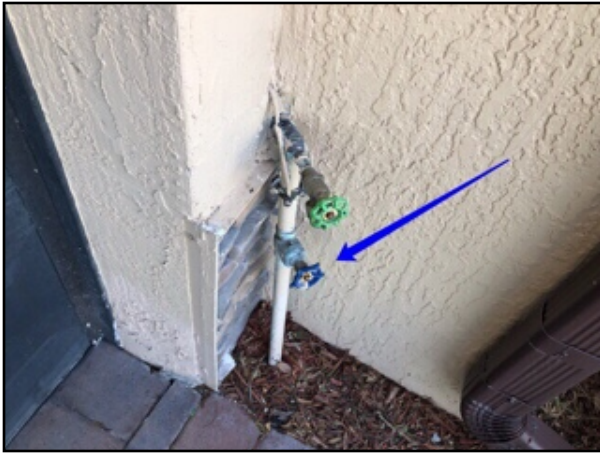
Figure 11-1

Comment 11:  
Main water shut off .

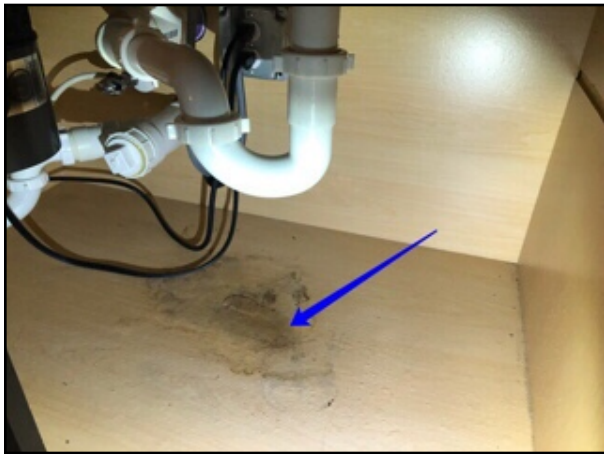
Figure 12-3

Active plumbing leak under the kitchen sink.

The connection from the sink to the drainage pipe was leaking during the time of inspection.

Recommend correction and further evaluation by a licensed plumbing contractor.

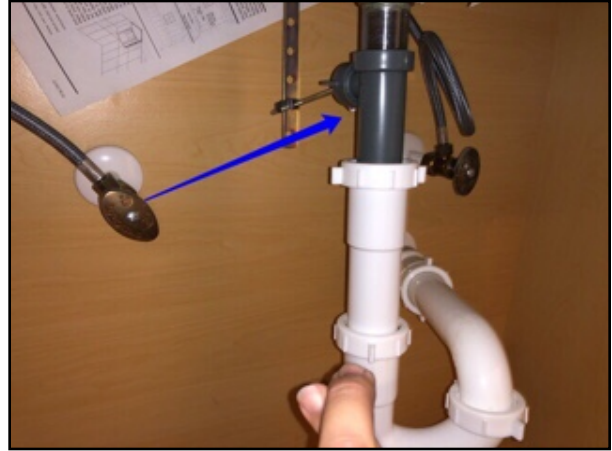
Figure 13-2

Master bathroom sink was leaking during the time of inspection. The pipe that connects to the drainage line was leaking when I touched it. Recommend correction and further evaluation by a licensed plumbing contractor.

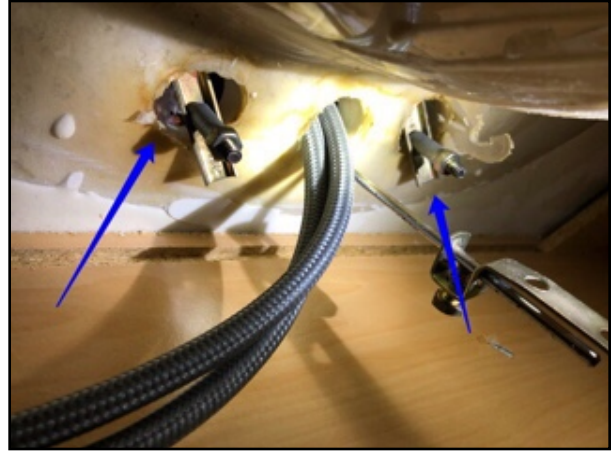
Figure 16-2

**Comment 16:**  
Sink faucet in downstairs bathroom is loose and improperly installed.  
Recommend correction by a licensed plumbing contractor.

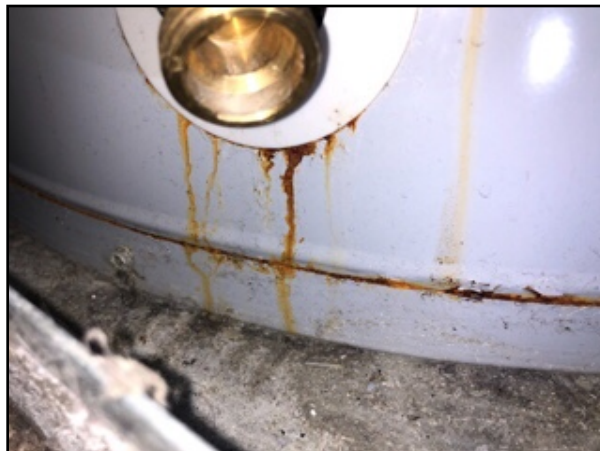
Figure 17-2

Water heater was not functioning at the time of inspection.  
Water heater Was also showing signs of rusting at its base.  
Recommend correction by a licensed plumbing contractor.

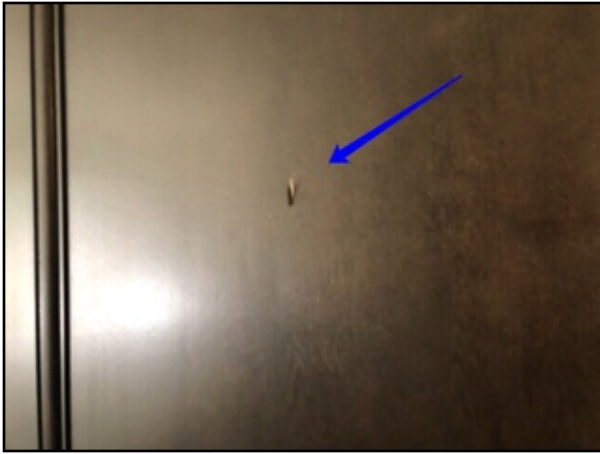
Figure 24-1

Comment 24:  
Minor chips and scratches on kitchen cabinets.

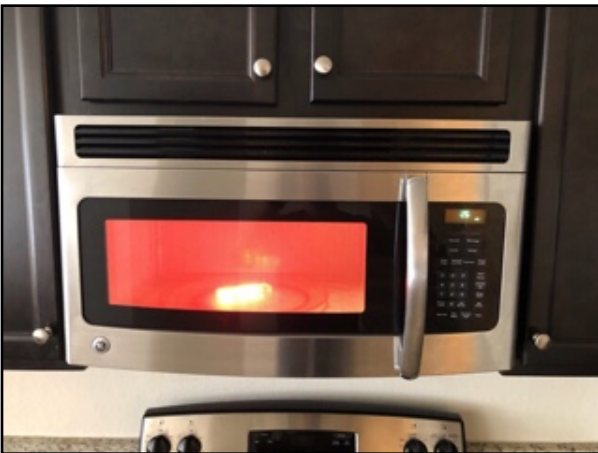
Figure 31-1

Comment 31:  
LED lights in the picture indicate that the microwave was working satisfactory during the time of the inspection.

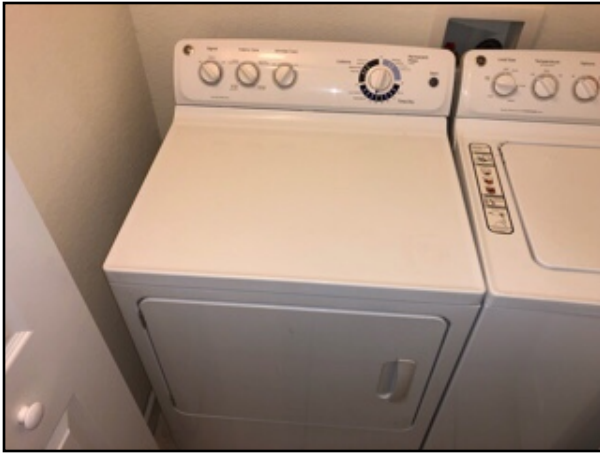
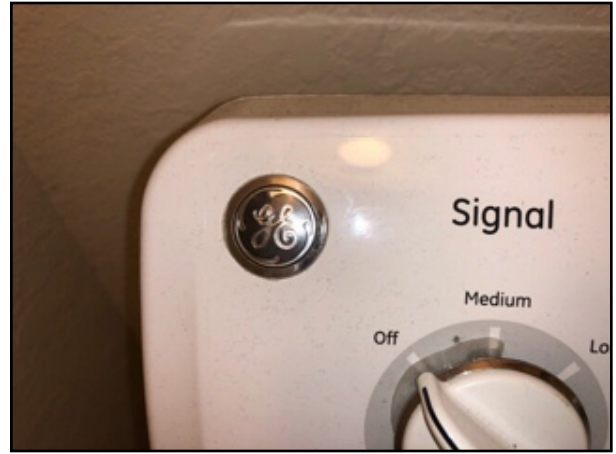
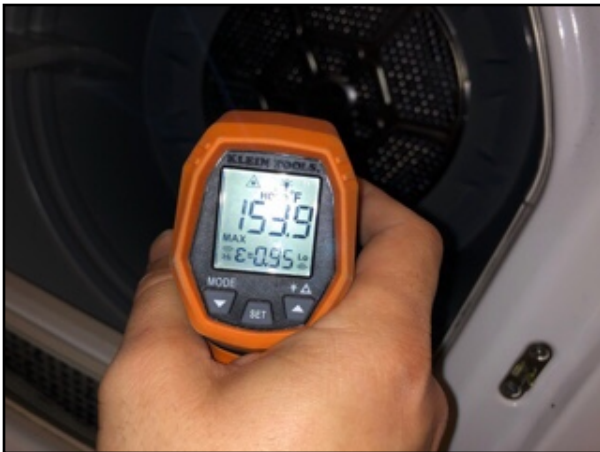
Comment 34:  
Dryer .

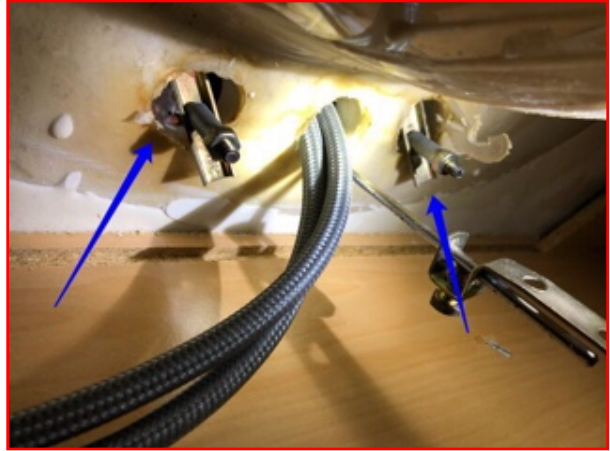
Figure 16-2

5) Sink faucet in downstairs bathroom is loose and improperly installed.  
Recommend correction by a licensed plumbing contractor.

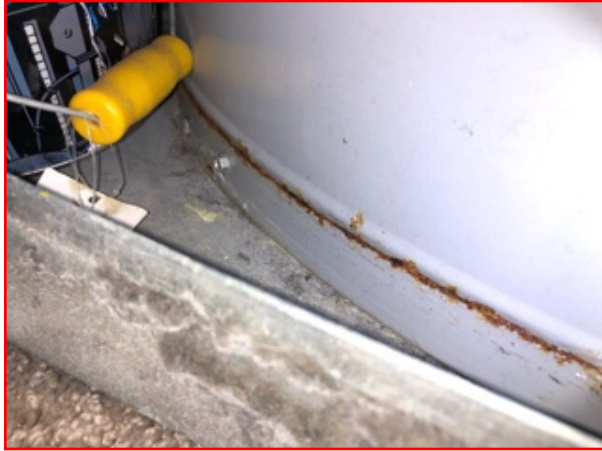
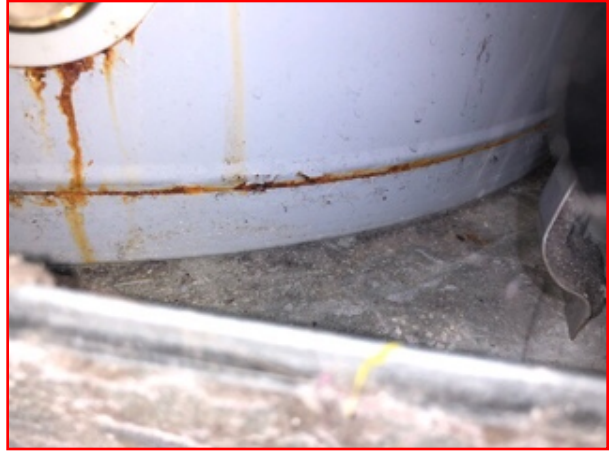
6) Water heater was not functioning at the time of inspection.  
Water heater Was also showing signs of rusting at its base.  
Recommend correction by a licensed plumbing contractor.

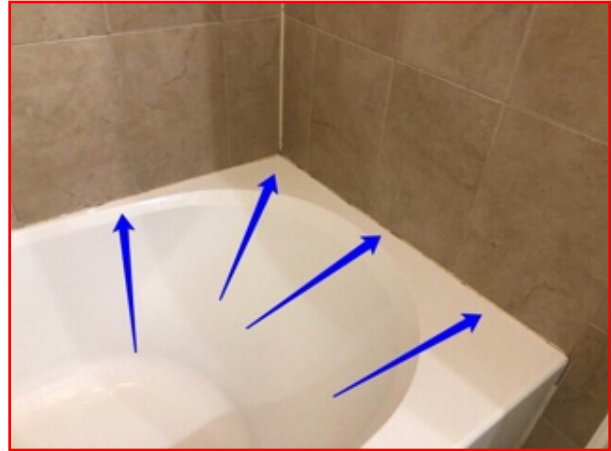
Figure 20-2

9) Recommend replacing worn caulking around the tub to help prevent moisture intrusion into wall structure.

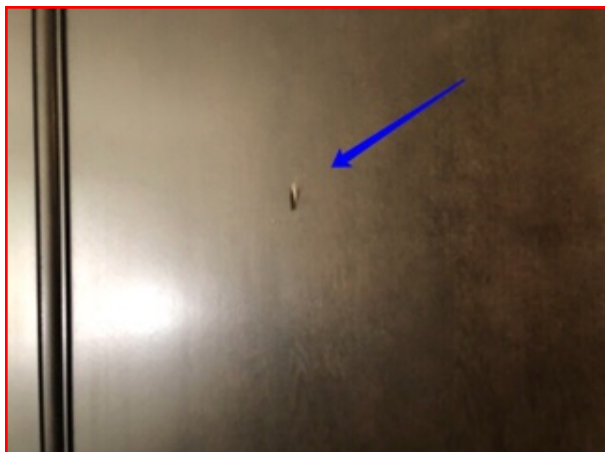
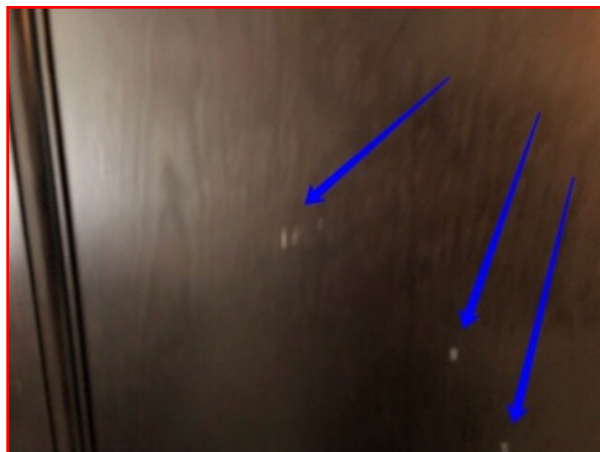
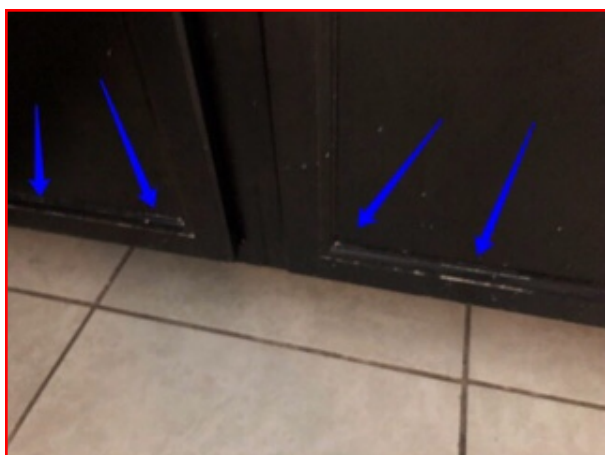
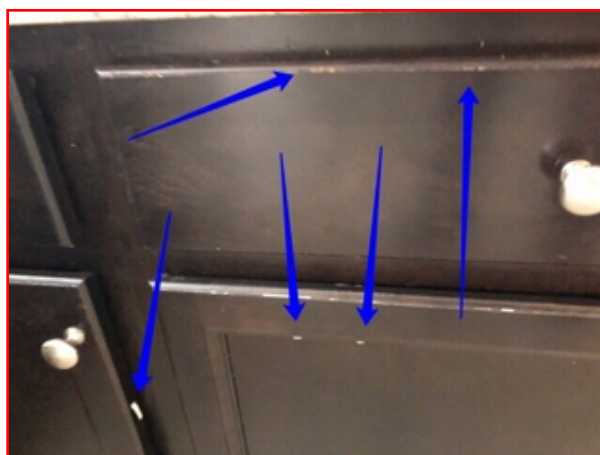
12) Minor chips and scratches on kitchen cabinets.
